February 10, 2023

RE: Potential Environmental and Public Safety Hazards at Drakes Beach

#### CLEAN WATER ACT SECTION 401 WATER QUALITY CERTIFICATION AND ORDER for:

Sir Francis Drake Boulevard Improvement Project, CA FLAP CR 109(1), Marin County

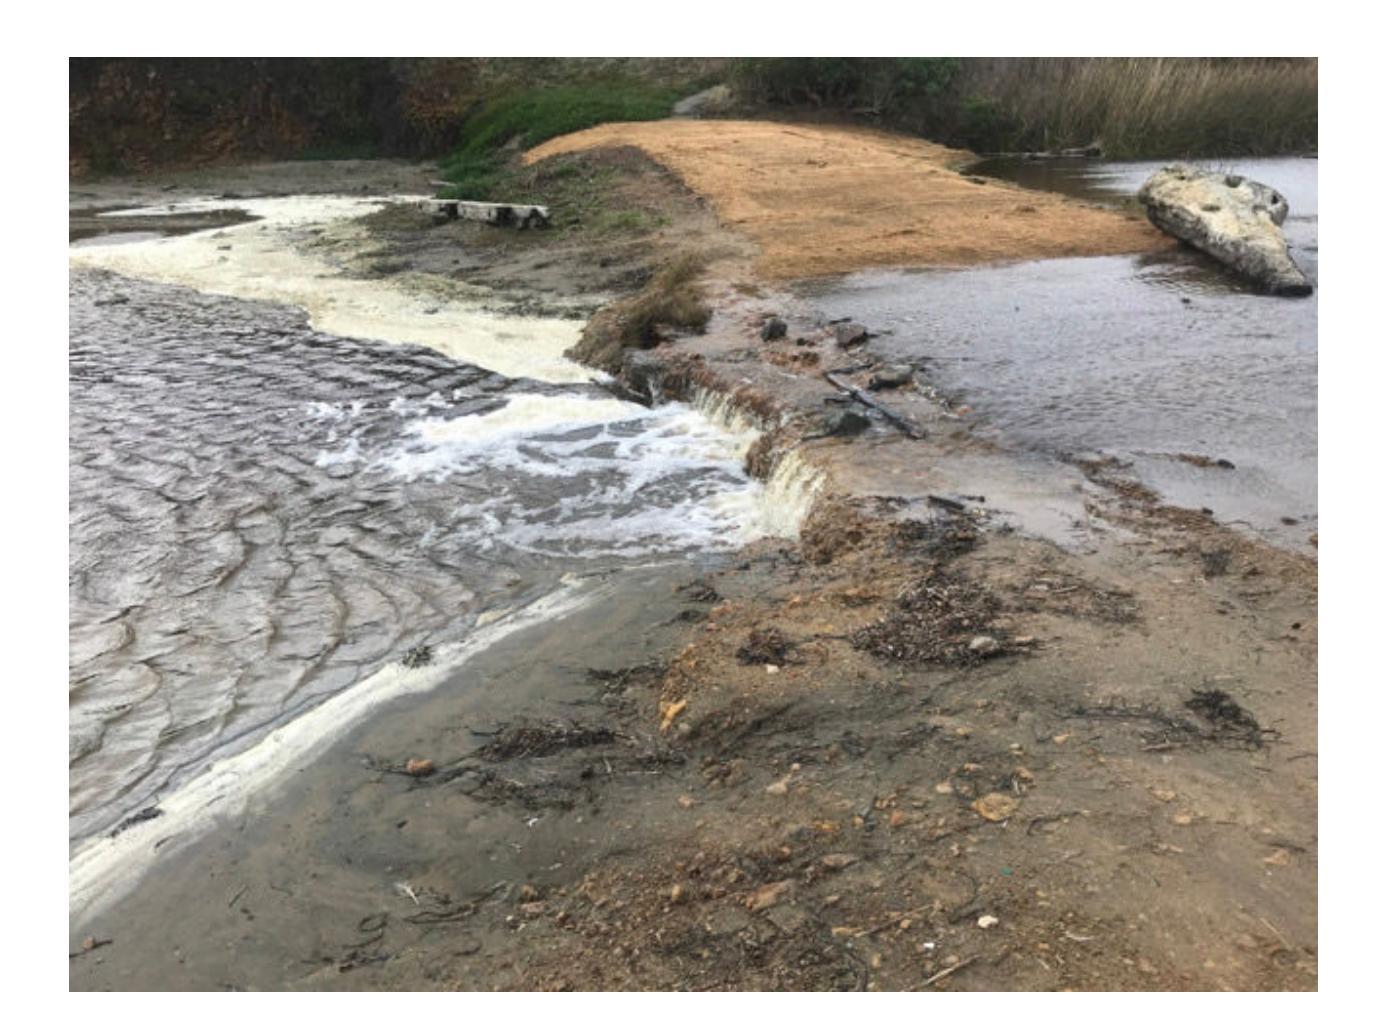
Figure 1. Condition of the Berm and Relict Sewer Line on January 3, 2023

Both the Finding of No Significant Impact<sup>1</sup> (FONSI) and the Joint Aquatic Resource Permit Application<sup>2</sup> (JARPA) for the wetland construction project indicate that the relict sewer line would be removed. Because it contains asbestos, the pipe was supposed to have been disposed of at a hazardous waste facility. For reasons that remain unclear, this work was not done. By January 2022, the relict pipe had been exposed by wave action and erosion from the wetland draining through the head cut on the berm. Photos in Attachments 1 and 2 show the condition of the berm and relict pipe at that time. Figure 1 shows those conditions on January 3, 2023, just prior to the recent series of atmospheric rivers.

We are concerned about deteriorating conditions related to post-construction impacts of the wetland restoration at Drakes Beach. We are writing to request that park management take action, as soon as practicable, to remediate potential environmental and public safety hazards at the site. These hazards are specifically related to the condition of the relict sewer pipe on the beach side of the wetland berm, as well as the active sewer line that lies more or less directly beneath the relict pipe.

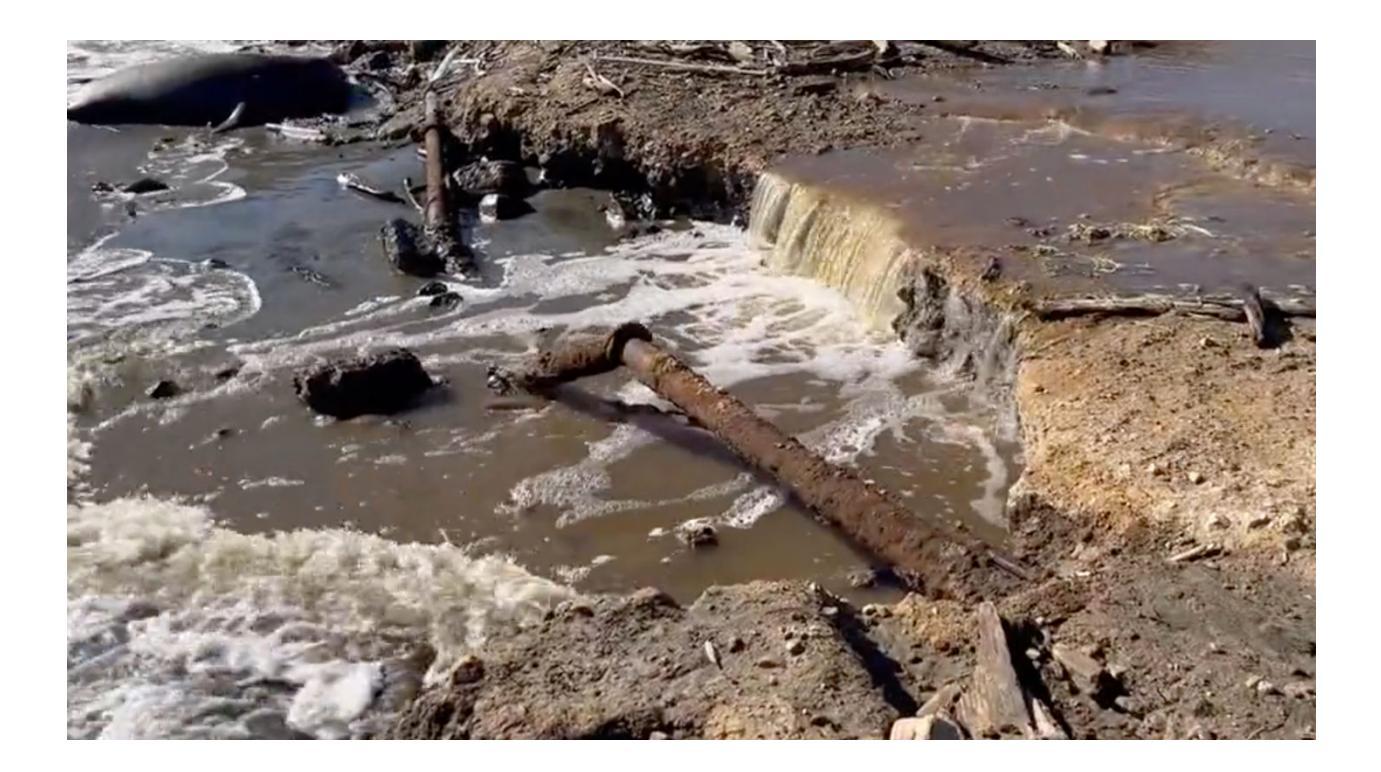
Figure 2 shows the berm and relict pipe as of January 24, 2023. The berm's head cut has expanded to the point where the relict pipe is completely exposed and is disconnected from its substrate. As hazardous waste, the relict pipe on a public beach is an environmental as well as health and safety hazard that must be remediated.

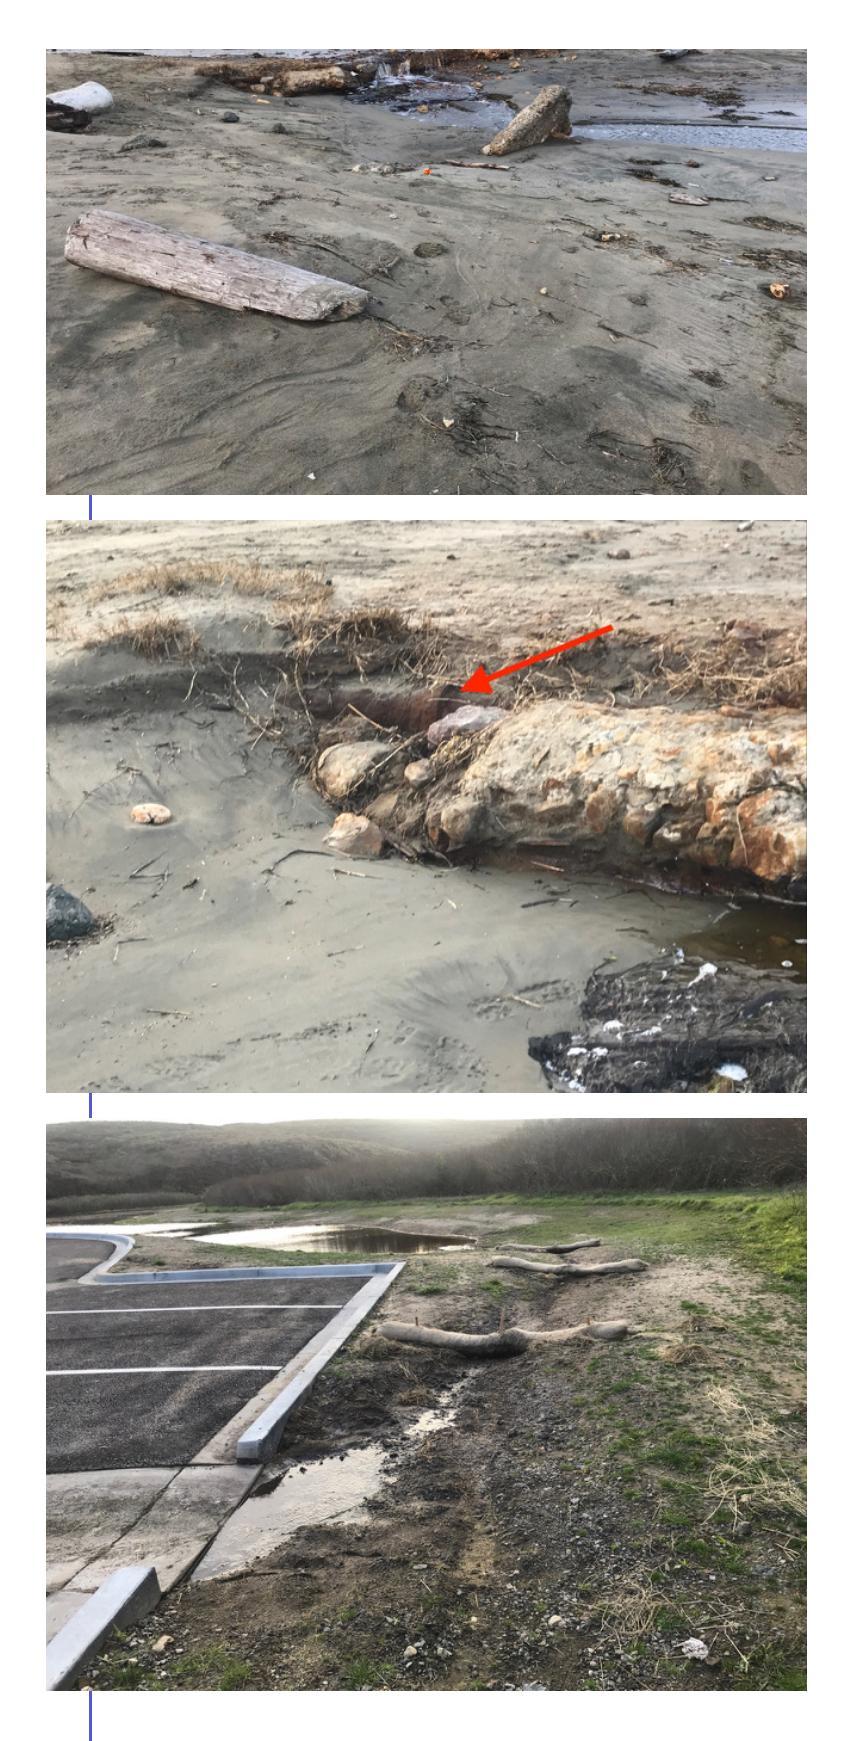
The erosion from the new wetland draining onto the beach is pretty extensive at this point, as shown in the first photo, with the large chunk of derelict concrete sticking up out of the sand. The second photo shows that the erosion has exposed the abandoned sewer line (red arrow), and if I remember correctly, the newer functional sewer line is in close proximity to the abandoned one. We're only half way through the winter, and I wonder what level of concern park staff has about the consequences of the inevitable further erosion of this area.

The third photo shows that the parking lot is draining directly into the wetland. I'm guessing from the straw wattles that park staff is trying to mitigate what appears to be a design or construction flaw. It looks like that makeshift effort isn't entirely successful.
