February 10, 2023

RE: Potential Environmental and Public Safety Hazards at Drakes Beach

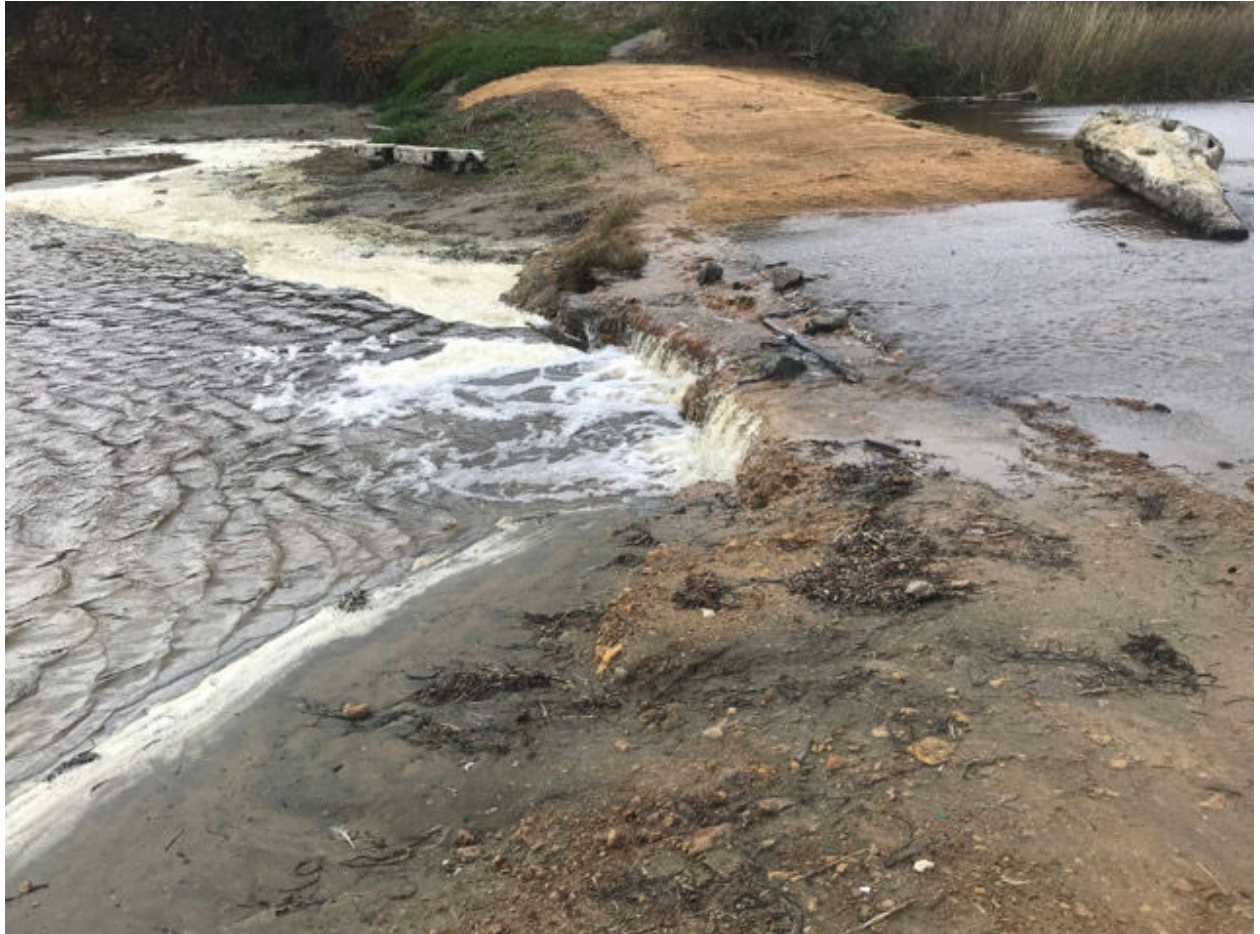
**Figure 1. Condition of the Berm and Relict Sewer Line on January 3, 2023**

Both the Finding of No Significant Impact<sup>1</sup> (FONSI) and the Joint Aquatic Resource Permit Application<sup>2</sup> (JARPA) for the wetland construction project indicate that the relict sewer line would be removed. Because it contains asbestos, the pipe was supposed to have been disposed of at a hazardous waste facility. For reasons that remain unclear, this work was not done. By January 2022, the relict pipe had been exposed by wave action and erosion from the wetland draining through the head cut on the berm. Photos in Attachments 1 and 2 show the condition of the berm and relict pipe at that time. Figure 1 shows those conditions on January 3, 2023, just prior to the recent series of atmospheric rivers.

We are concerned about deteriorating conditions related to post-construction impacts of the wetland restoration at Drakes Beach. We are writing to request that park management take action, as soon as practicable, to remediate potential environmental and public safety hazards at the site. These hazards are specifically related to the condition of the relict sewer pipe on the beach side of the wetland berm, as well as the active sewer line that lies more or less directly beneath the relict pipe.

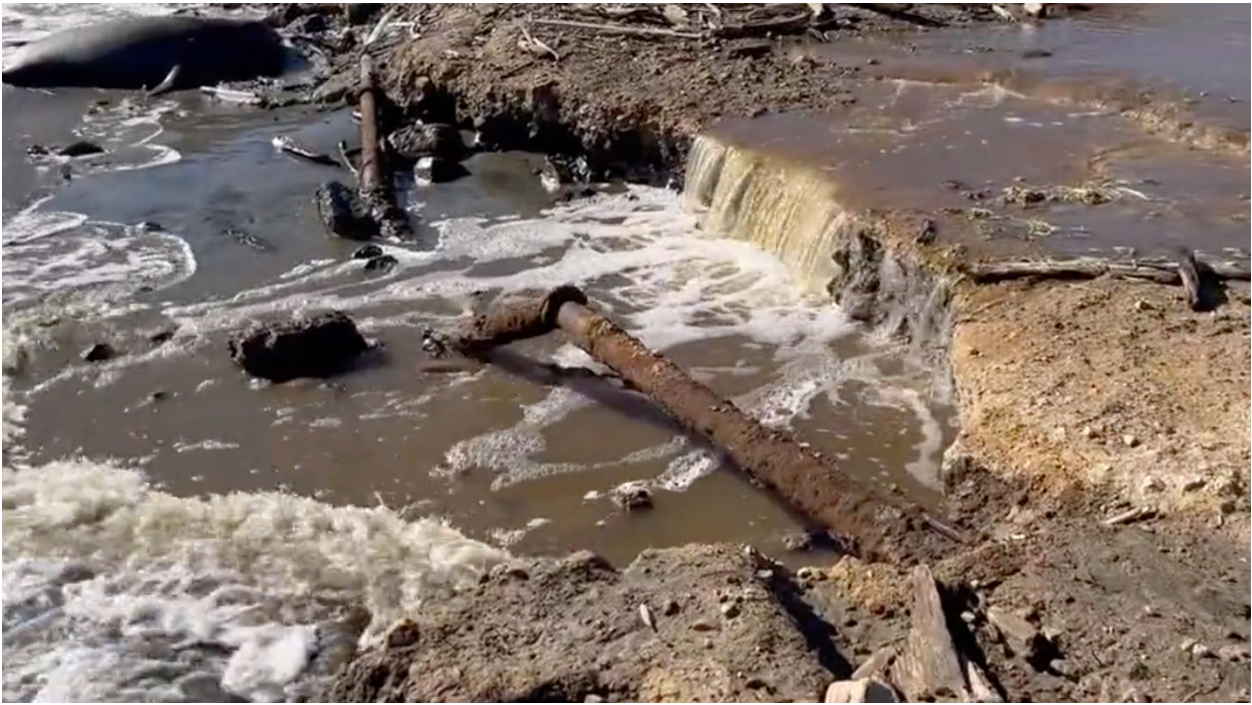
**Figure 2. Condition of the Berm and Relict Sewer Line on January 24, 2023**

Figure 2 shows the berm and relict pipe as of January 24, 2023. The berm's head cut has expanded to the point where the relict pipe is completely exposed and is disconnected from its substrate. As hazardous waste, the relict pipe on a public beach is an environmental as well as health and safety hazard that must be remediated.

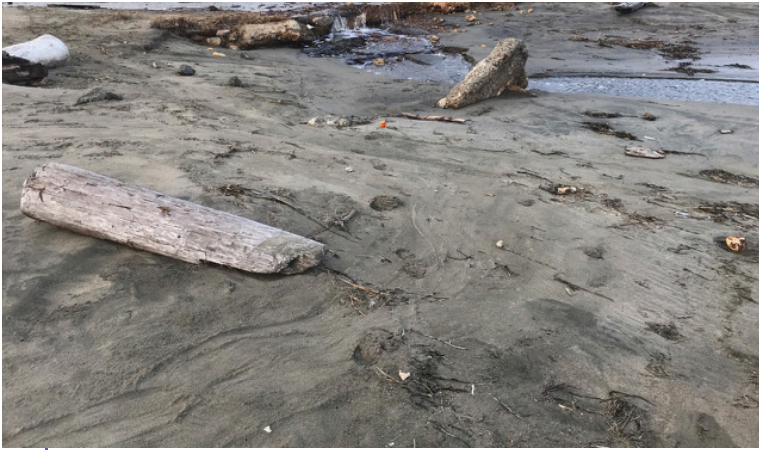
The erosion from the new wetland draining onto the beach is pretty extensive at this point, as shown in the first photo, with the large chunk of derelict concrete sticking up out of the sand. The second photo shows that the erosion has exposed the abandoned sewer line (red arrow), and if I remember correctly, the newer functional sewer line is in close proximity to the abandoned one. We're only half way through the winter, and I wonder what level of concern park staff has about the consequences of the inevitable further erosion of this area.

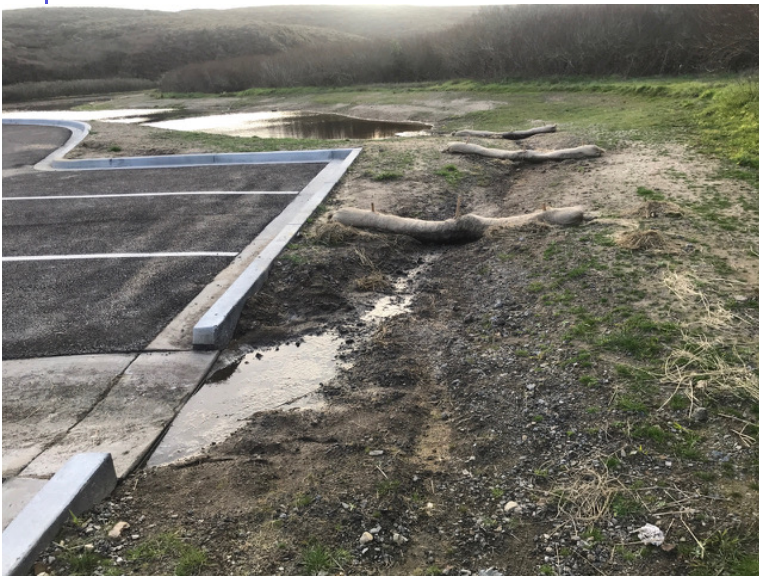
The third photo shows that the parking lot is draining directly into the wetland. I'm guessing from the straw wattles that park staff is trying to mitigate what appears to be a design or construction flaw. It looks like that makeshift effort isn't entirely successful.
